Floating UPS Ground February 5, 2004, Minor Shock

Floating UPS Ground February 5, 2004

Minor Shock

Gary Dreifuerst
NIF Safety Engineer
February 9, 2004

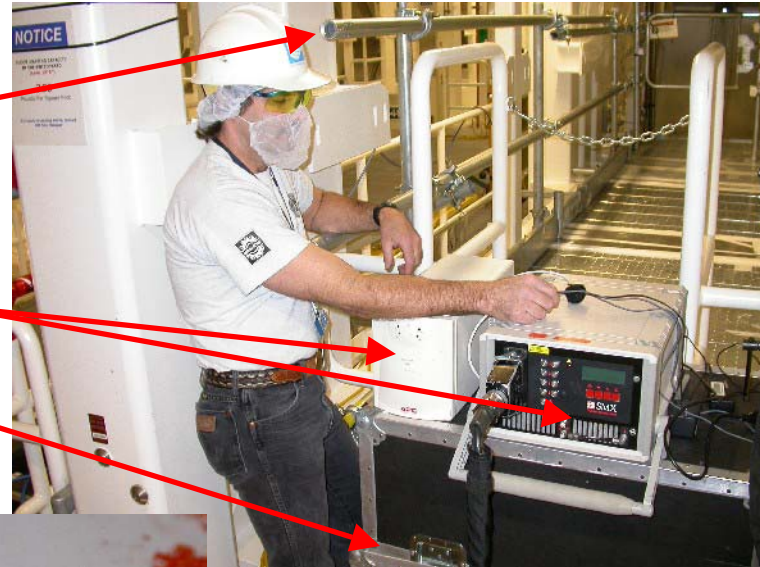
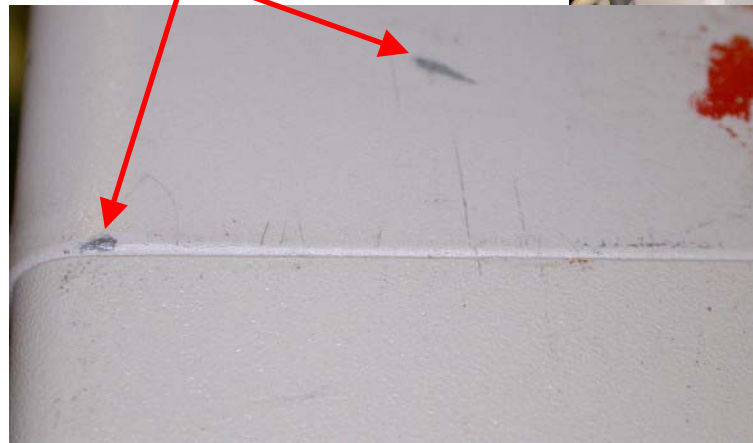
The Incident Scene

- Laptop was Removed Earlier from Top of SMX
- Grounded Scaffolding
- Ungrounded (54VAC) Chassis
- Ungrounded (54VAC) Edging
- UPS Paint Nicks

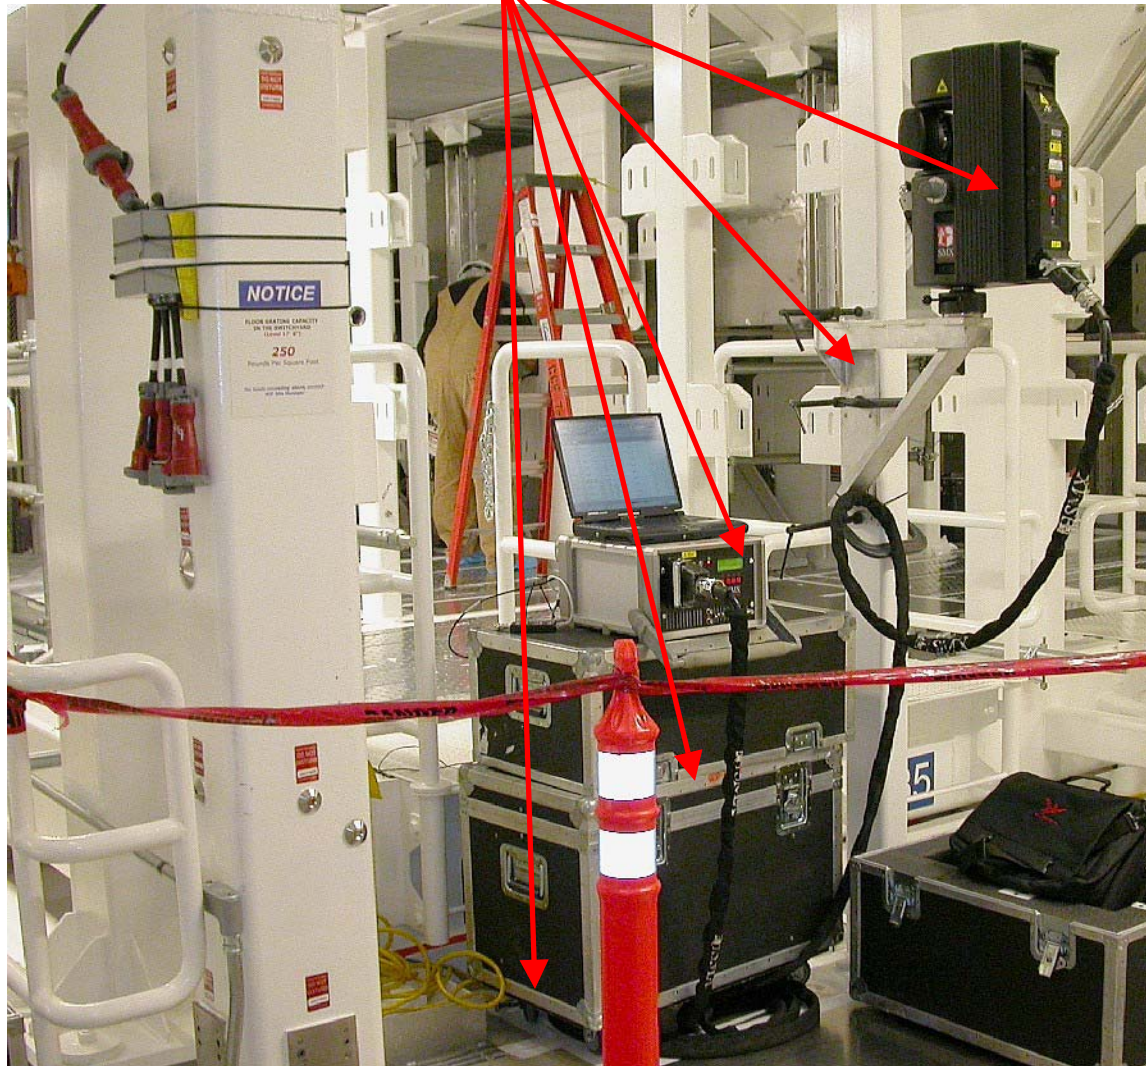
The Incident Scene – Big Picture

- UPS was removed
- Equipment at 54 VAC above Ground

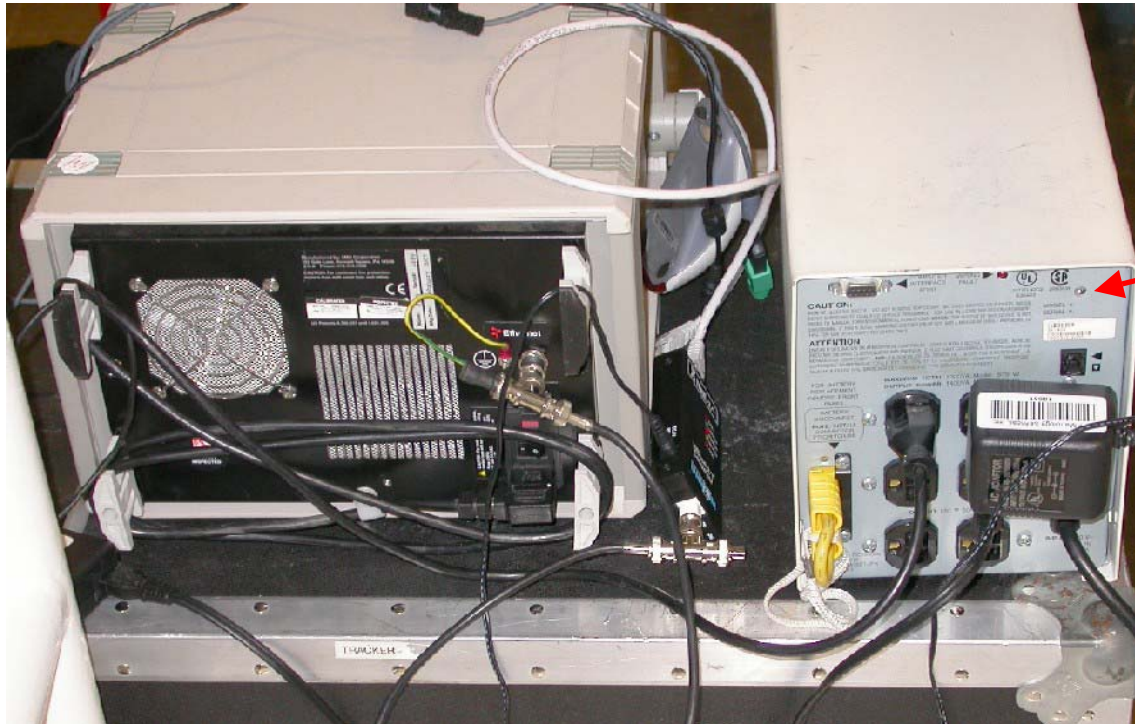
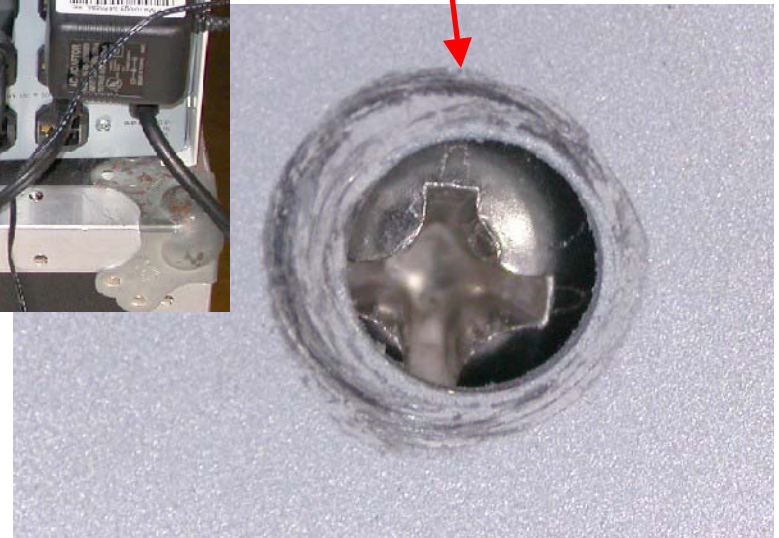
Chassis Rear at Scene

- The Clue is Here, It's Really Small
- Improperly Reassembled Chassis has Ground Screw INSIDE Chassis

- Normal Day's Work in SY2
 - Setup Precision Laser Survey Equipment
 - ~11am “Caught” Arm Hair on UPS Top Panel
 - ~3:20pm, Same Arm Feeling Again--Maybe this is a SHOCK!!!
- Not a Normal Day Anymore
 - Worker notifies his NIF Supervisor, who calls NIF Management and then 911 is called
 - Always call 911 first in an Emergency
- To Avoid Equipment Problems
 - Always do a Visual Inspection of Your Tools Before Using Them
 - Look for Signs that it was Reworked and not Reassembled Completely
 - If in Doubt--DO NOT USE IT--Contact a Subject Matter Expert

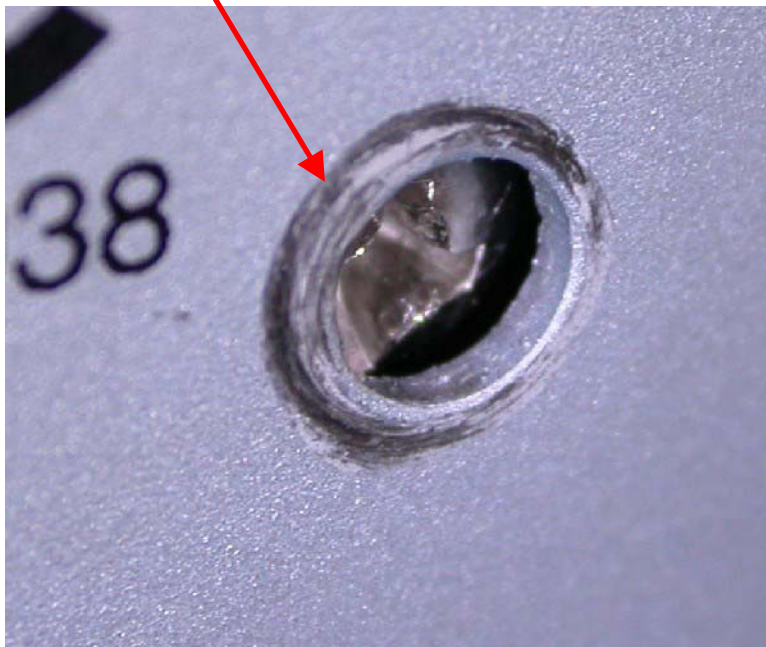
- Ground Connection Depends on a Bolt that Connects Green Wire from Cord to Chassis and to PWB Tab

— Angle View shows Scoring

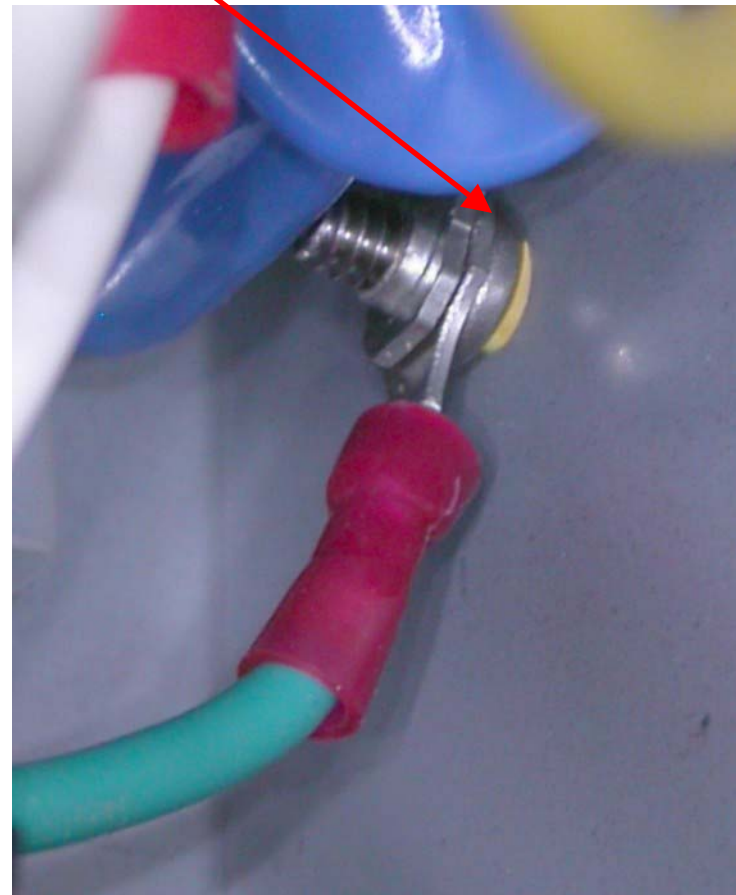
— Screw-Chassis Gap so Close

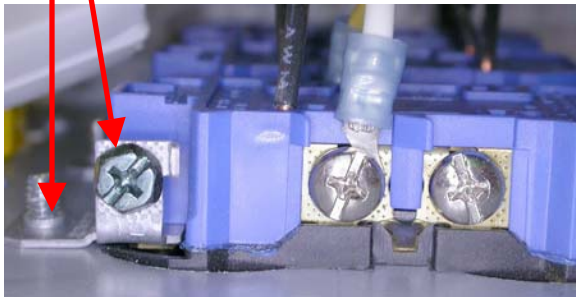
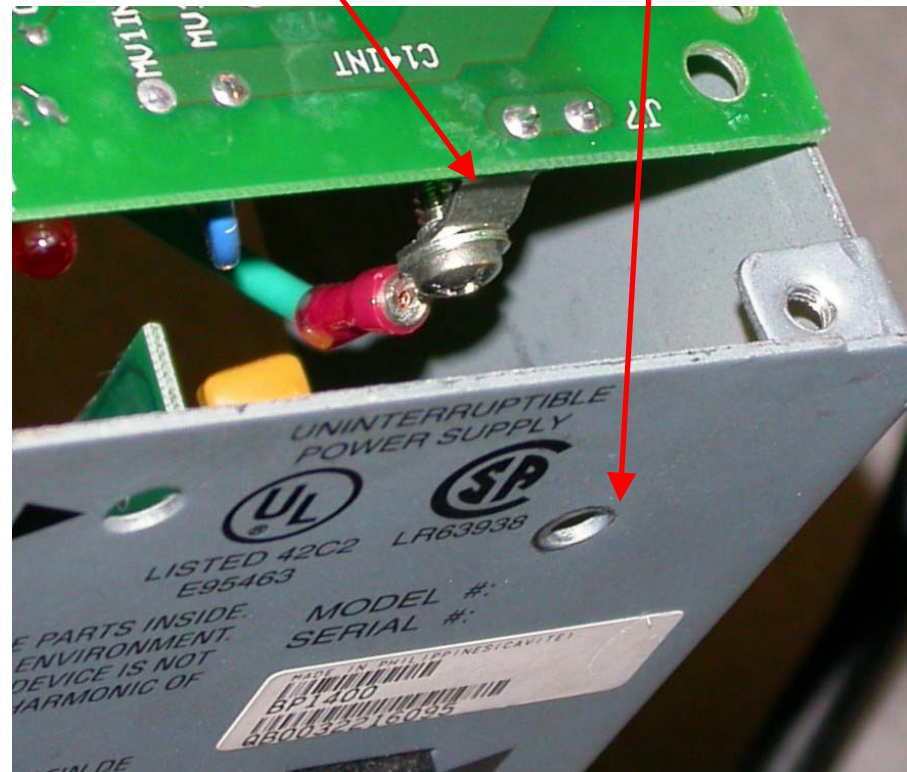
Inside the UPS - Receptacle Bonding

- Ground Connection Depends on a Bolt that Connects Green Wire from Cord to Chassis Plate and to PWB Tab
 - No Wired Connection to Ground Tab
 - Receptacle Ground
 - Depends on Chassis
 - PWB Tab J7
 - Ground Hole

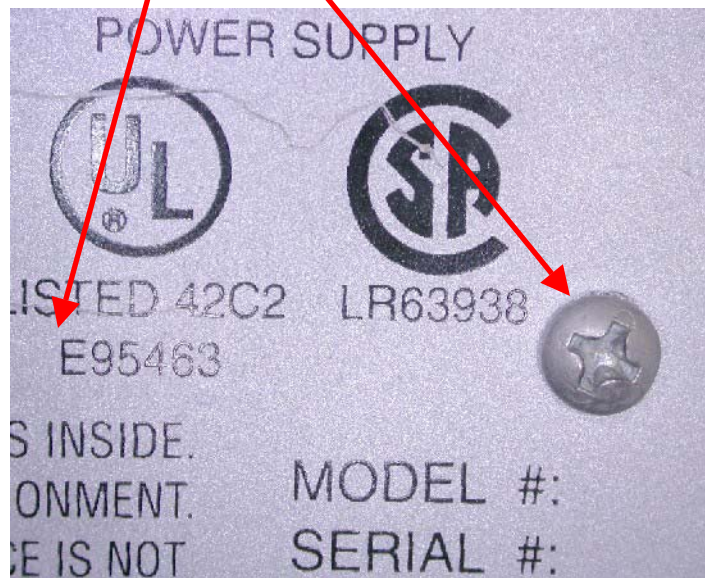
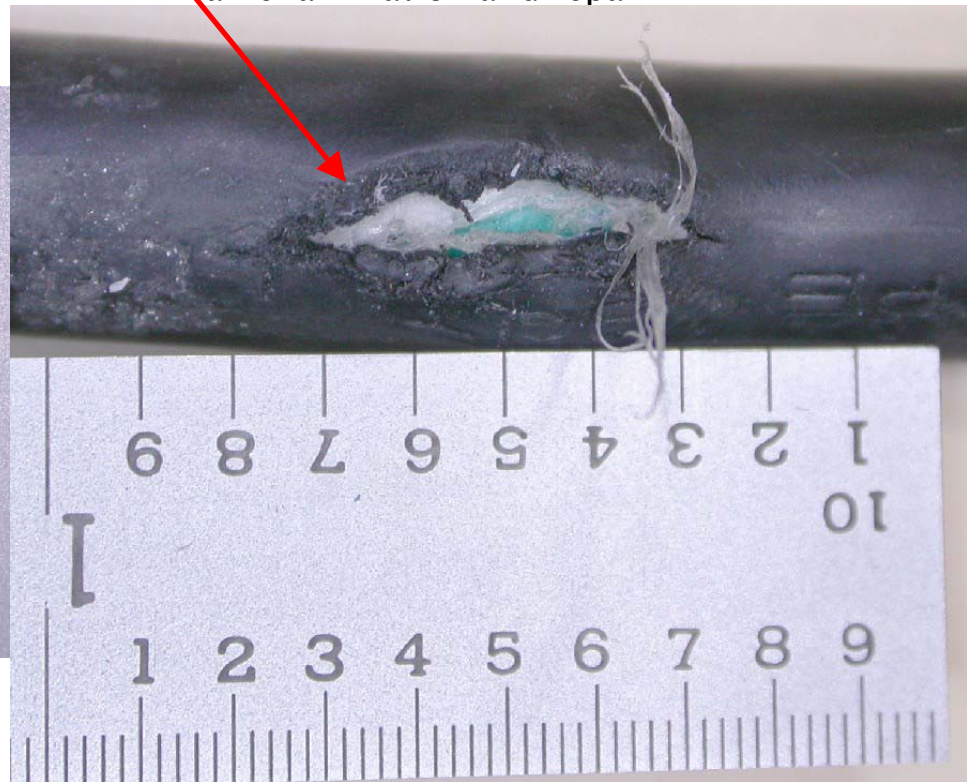
A Good UPS and the Damaged Cord

- Unmodified UPS Tests out Perfectly and Early Clue to the Problem
 - UL Listing
 - Listing Number
 - Proper Ground Screw
 - Tear in Jacket of UPS Power Cable
 - This did not affect the UPS Grounding
 - Rejection of the UPS for this may have forced an examination and repair

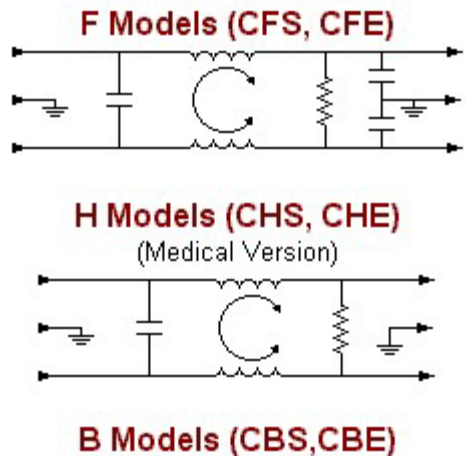
Electrical Schematic

- The Capacitive Filter Depends on a Ground Terminal to return the Filter Current
 - Without a Ground Connection, Current is Injected into the Chassis
 - Typical Chassis RFI Filter shown Below

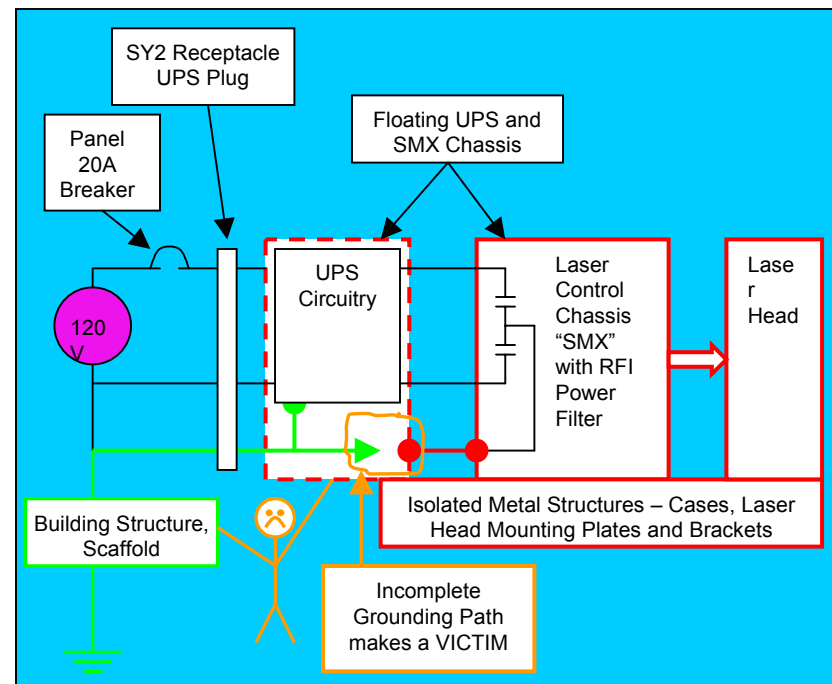
- The Output Receptacle of the UPS was not Bonded to the Input “Green” Wire
 - Load RFI Filter Injected Current into all the Chassis
